ST GILES CHURCH
WEST BRIDGFORD, NOTTINGHAM

ARCHAEOLOGICAL EVALUATION

APRIL 1988

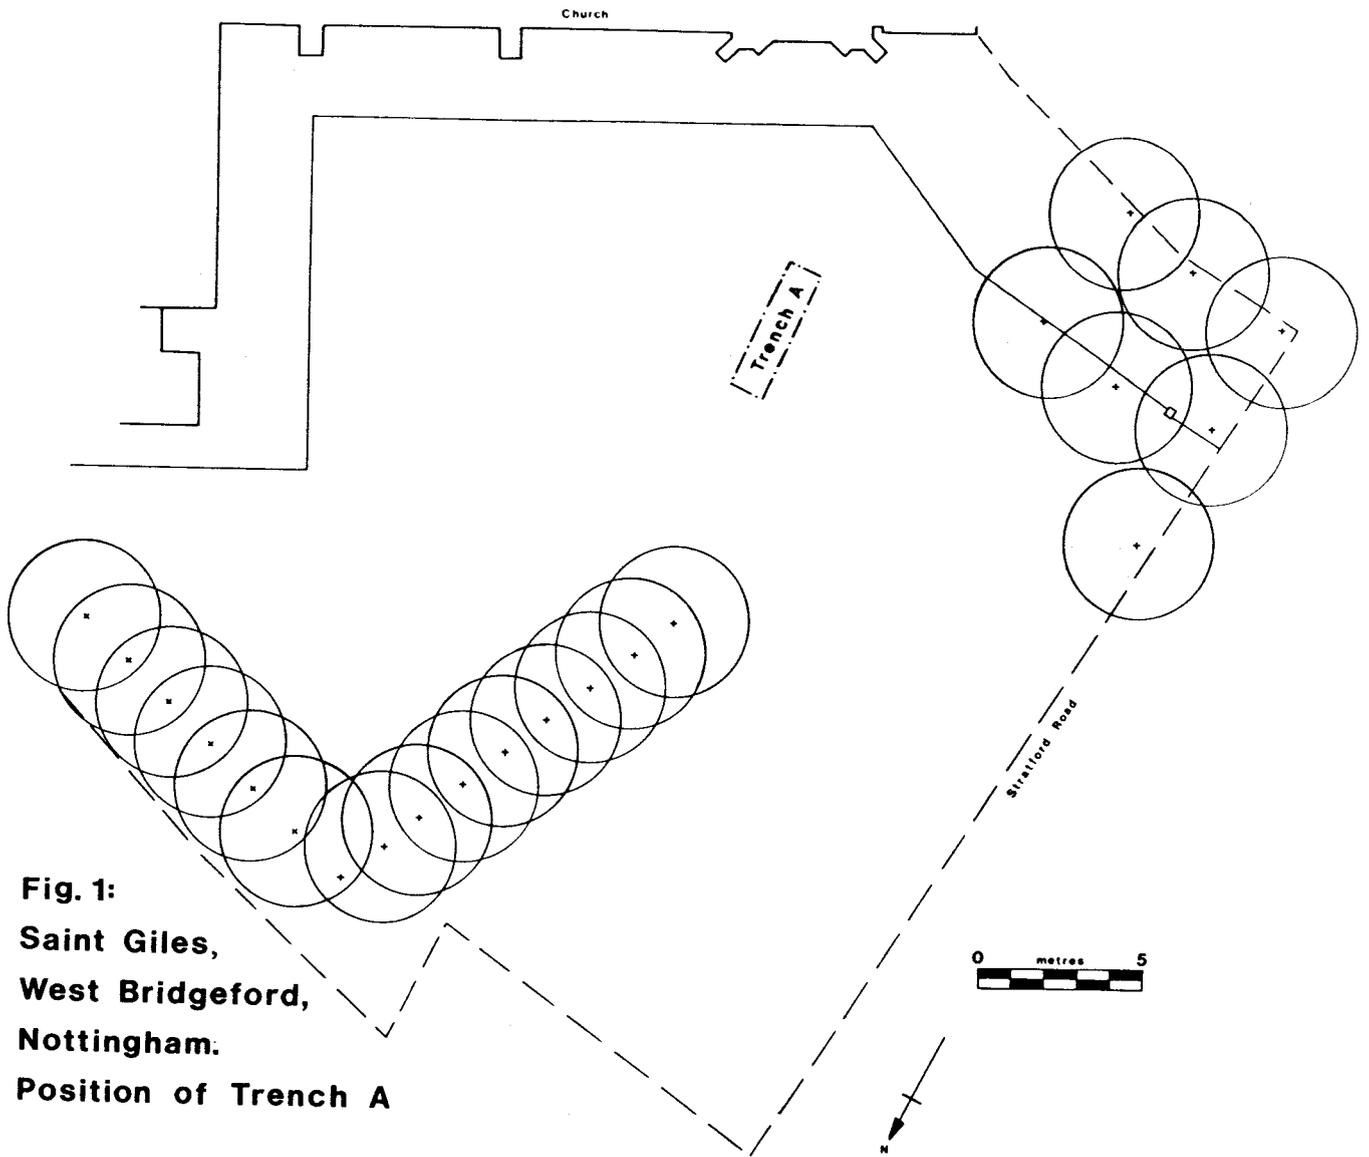
Fig. 1:
Saint Giles,
West Bridgeford,
Nottingham.
Position of Trench A

A trench (trench A) of 4.00m. x 1.00m. was excavated approximately 8.00m north-east of the church (fig 1). The trench was excavated in part, to a depth of 0.92m (fig 4).

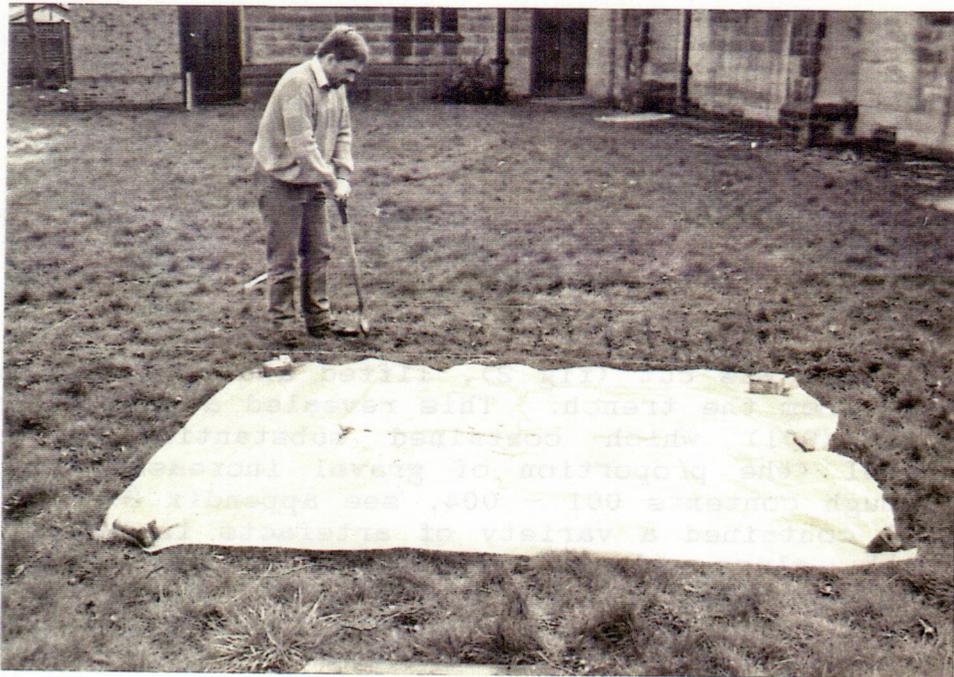
FIG 2: REMOVING TURF FROM TRENCH A.

The turf was cut (fig 2), lifted and carefully stacked away from the trench. This revealed a dark sandy loam soil (001) which contained substantial amounts of gravel (the proportion of gravel increased with depth through contexts 001 - 004, see appendix 2). This top soil contained a variety of artefacts including modern brick, glass, glazed pottery, stoneware, slate, lead, tile, corroded iron nails, and flint; some of which was worked and of prehistoric origin (appendix 1). The top soil extended to a depth of 0.28m.

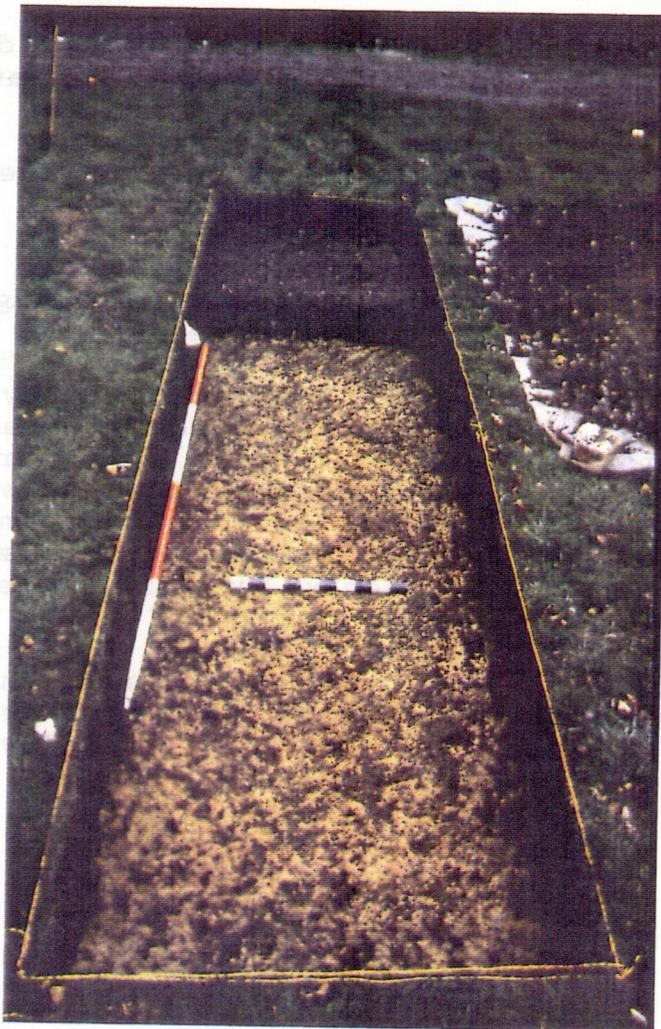
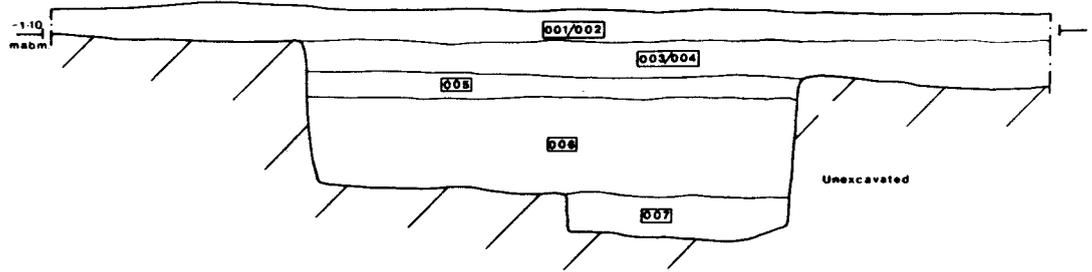
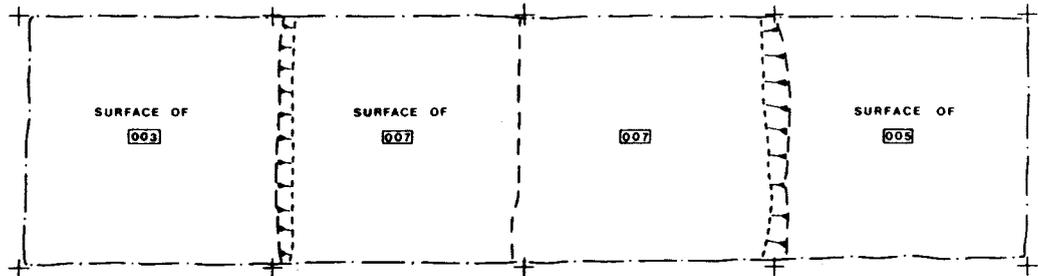
Fig. 4: Saint Giles, West Bridgeford, Nottingham

Immediately below (001-004) was a much lighter brown sandy-mortar layer (005) some 0.08m thick (fig 3). (005) contained much broken stone and brick. This compacted layer is typical of bedding material for a tile or flagstone surface, no trace of which survives.

Beneath (005) lay (006), a substantial deposit; 0.38m. thick; of building rubble within a matrix of sandy loam. (006) contained large amounts of fragmented dressed and undressed stone, pink mortar nodules, tile, 17th or 18th century brick and two sherds of modern stoneware pottery. This deposit has all the appearance of 'hardcore' used to provide a firm base for the surface above (005), and most probably came from the destruction of nearby brick buildings and waste material from other sources (see figs 5 & 6).

The rubble layer (006) was underlain by a sandy loam soil (007), which contained some stone, brick (with white and cream mortar), slate and corroded ironwork. This deposit appeared to have been somewhat disturbed and was quite soft. The disturbed nature of 007 suggests that further archaeological features may be present, but more deeply buried; however, the trench was excavated to a depth of 0.92 metres which apparently is already deeper than the proposed foundations of the new building and thus any further archaeological deposits should remain undisturbed. It should be noted that (007) was not fully excavated and continues to an undefined greater depth.

East facing section and plan, Trench A: 2/4/88

Layer (007), found in the bottom of trench A, appears to be an earlier buried soil horizon; presumably representing the old ground surface prior to subsequent deposition of the rubble layer (006). The nature of layer (007) could be the result of disturbances to the soil, which given the location of the excavation, may well be connected with grave digging. Even though this area is some distance to the north of the medieval church the existence of graves here would not be unusual. However, if burials are present, they are unlikely to cause problems for the construction of the church hall as they will be at least 1 metre deeper than the lowest point of trench A. No grave cuts were visible in (007).

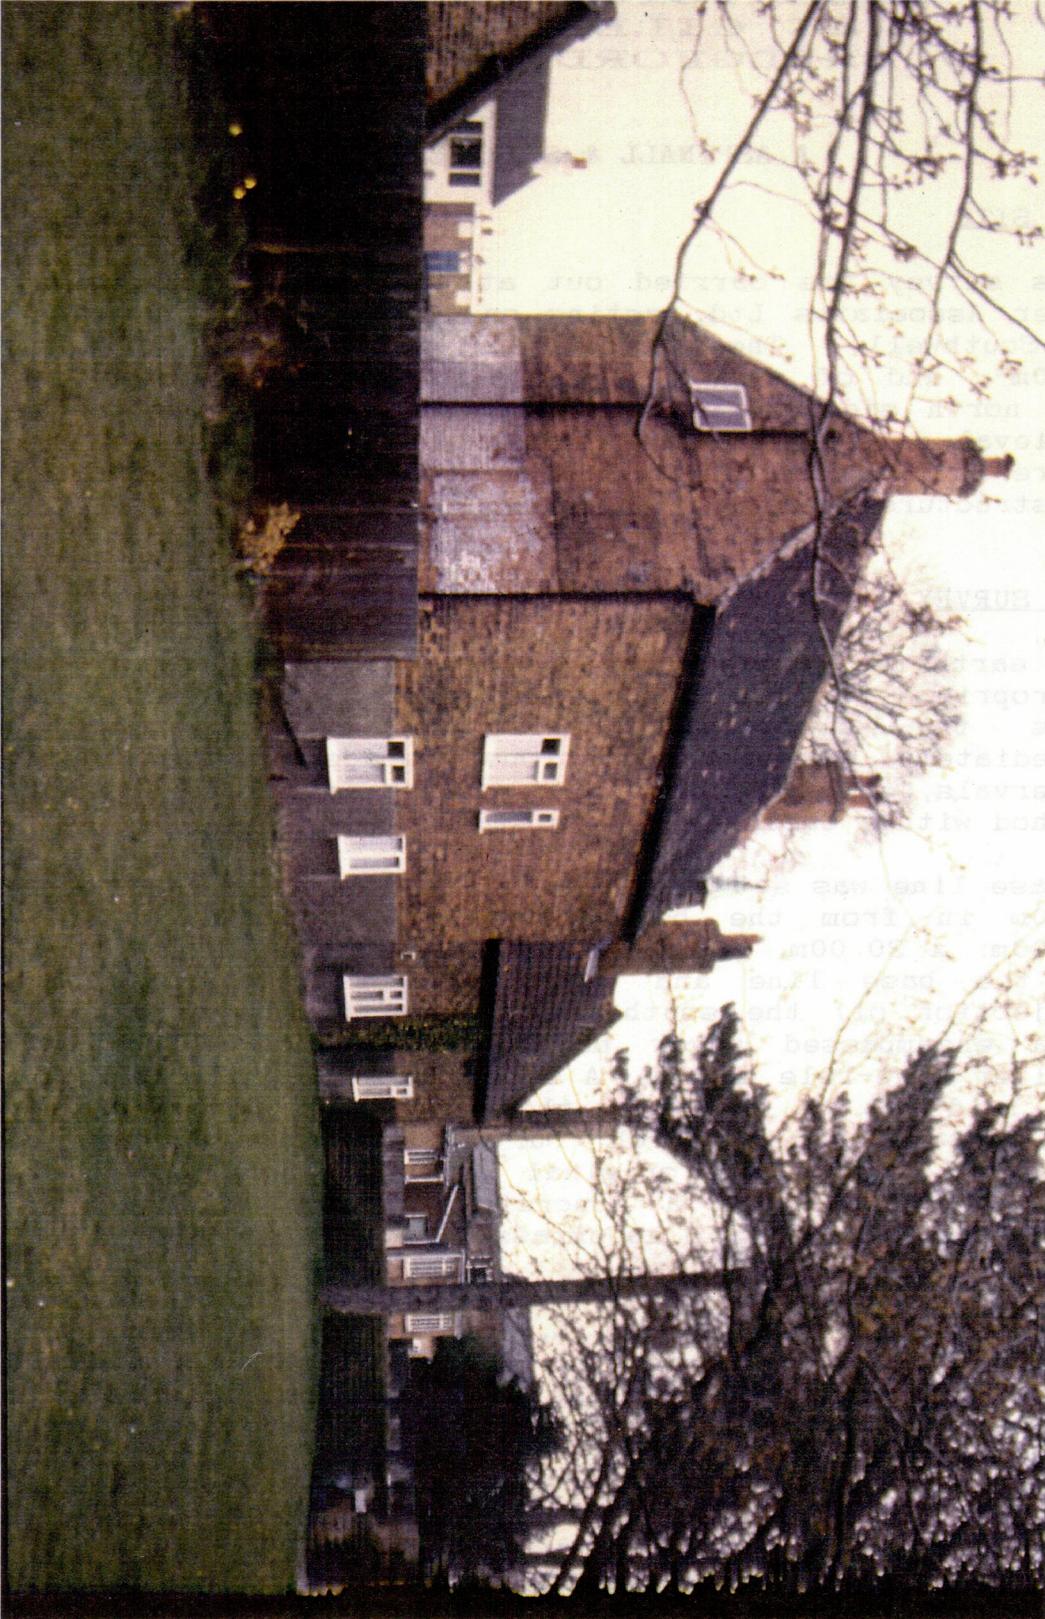
FIG 7: 17TH CENTURY HOUSE TO SOUTH EAST OF THE CHURCH

At some point within the last 100-150 years; possibly associated with the extension of the church in 1896-8 or 1911; one or more 17th century brick buildings had been demolished on or near the site. These may well have been similar in construction to the cottages which stand at the east corner of the churchyard, constructed in 1695 of brick similar to that found in (006). The presence of fragments of dressed stone in (006) further suggests that this event was linked with the late 19th/early 20th century extensions to the church. This rubble had been used as 'hardcore' to level the area, providing a firm foundation for a substantial surface. This surface may have been tiled or, more likely, flagged, and may have been a 'yard' area or the floor of a building. We have however, found no evidence for the presence of enclosing walls.
